Docket No. 217 – Development and Management Plan Inspection

Northeast Utilities Service Company Certificate of Environmental Compatibility and Public Need for the construction of a 345-kV electric transmission line and reconstruction of an existing 115-kV electric transmission line between Connecticut Light and Power Company's Plumtree Substation in Bethel, through the towns of Redding, Weston, and Wilton, and to the Norwalk Substation in Norwalk, Connecticut.

Date: August 19, 2005

Location: Transition Stations (Hoyts Hill, Archers Lane)

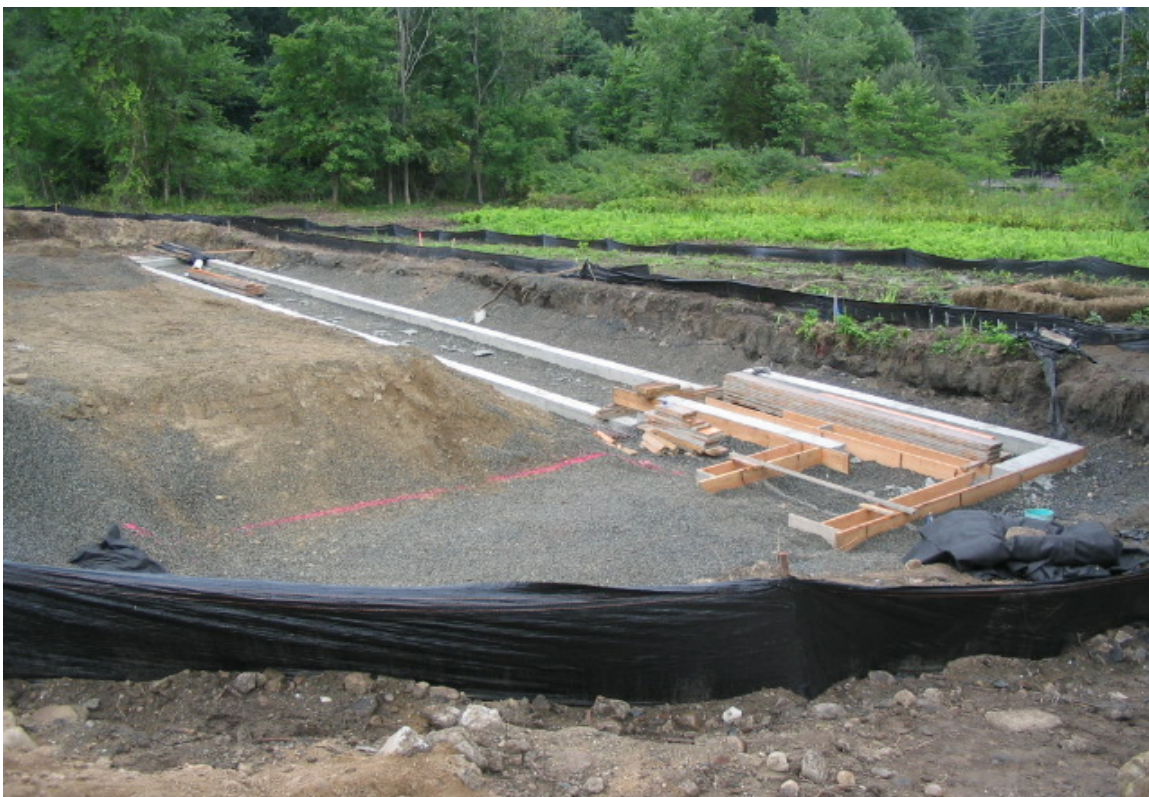
Hoyts Hill Transition Station: Overall view of the earthwork occurring at the site and initial foundation work. (8/19/05)

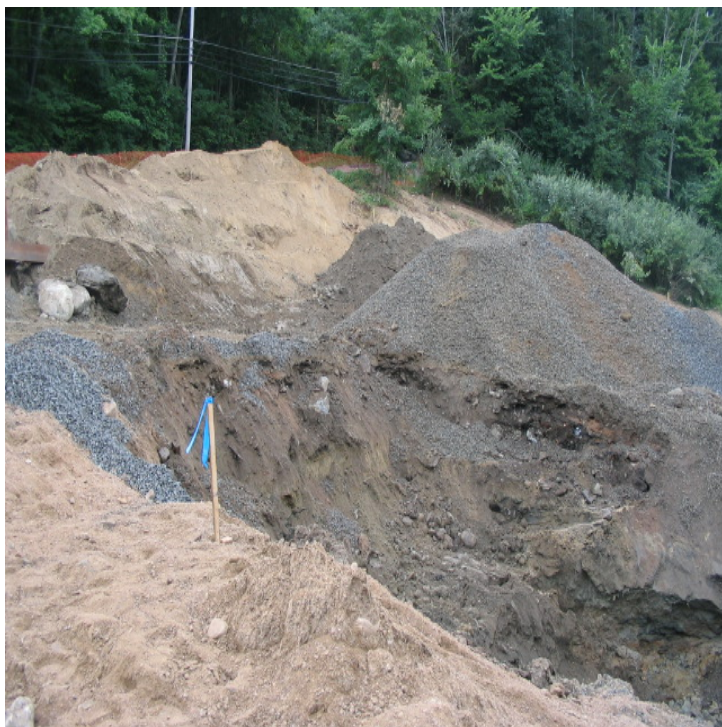
Photo on the left shows some of the earthwork. Photo on the right shows the dewatering corral in active use. All silt fence remains in good condition. (8/19/05)

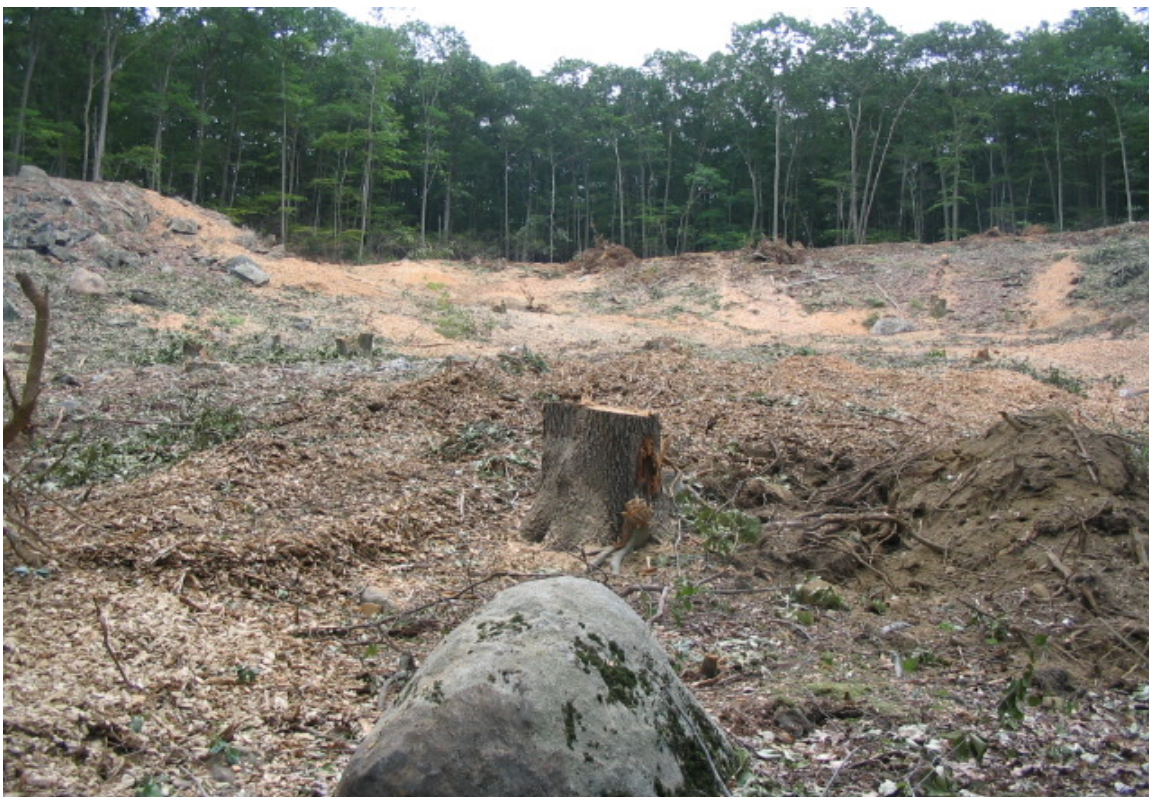
Archers Lane Transition Station: Work has been allowed to proceed and the station site has now been cleared. (8/19/05)

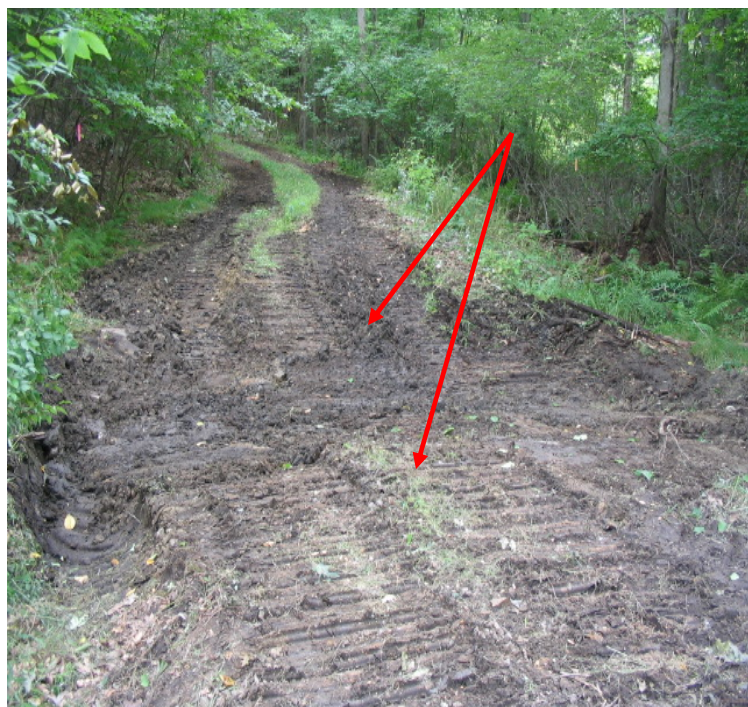
Photo on the left shows a low spot in the woods access path which is likely a wetland crossing. The area should be regraded and a timber mat used from now on to cross equipment. The photo on the right shows the extremely steep original access road to the site. (8/19/05)
